**1101 E. 10th Street #B
Austin TX 78703**

**Client(s): Chambers
Inspection Date: 2/6/2012**

PROPERTY INSPECTION REPORT

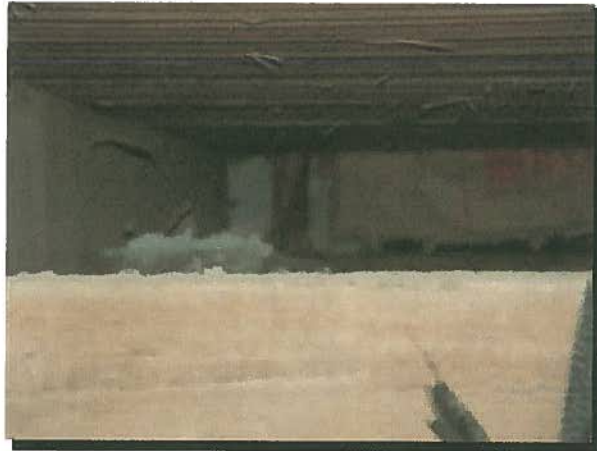
A. Picture 1 Interior section of foundation appeared in good condition.

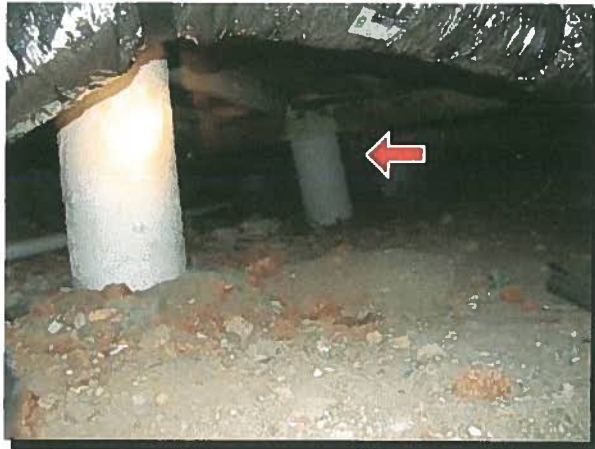
A. Picture 2

☒ Piers are not tied to beam structure of the home.

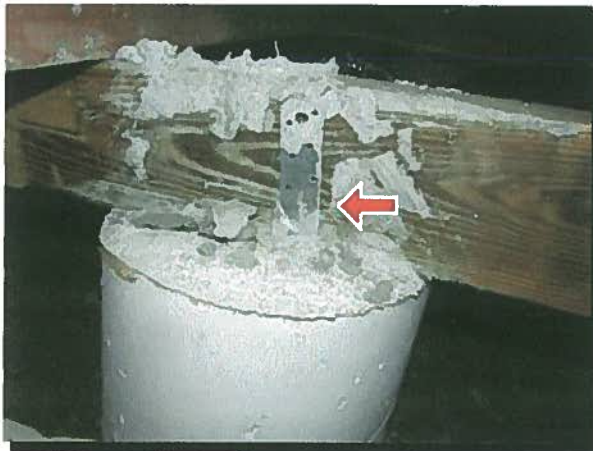
A. Picture 3 Tie downs present, but not attached to beams.

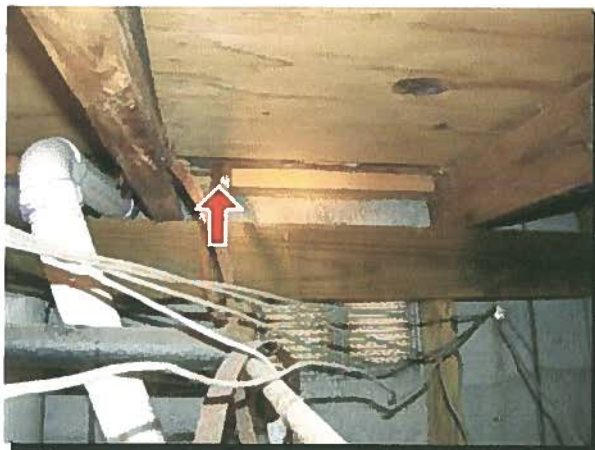
☒ Multiple areas observed below the house with various degrees of damage from water and/or wood destroying insects. The outer perimeter beam is deteriorated in multiple areas (rot and termite), most notably along the east wall. The sill plates for the wall studs are damaged from rot and termites. There is a high likelihood that upon removal of the exterior wall coverings, unseen damage to the interior wall structure (studs) will be uncovered.

A. Picture 4 2x4 member placed underneath rotted area.

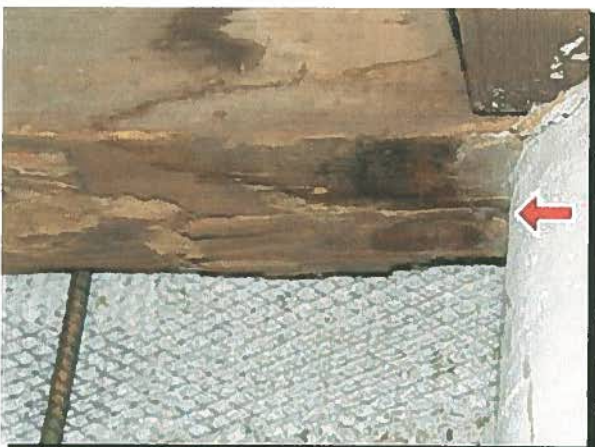
A. Picture 6 Damaged from termite, split.

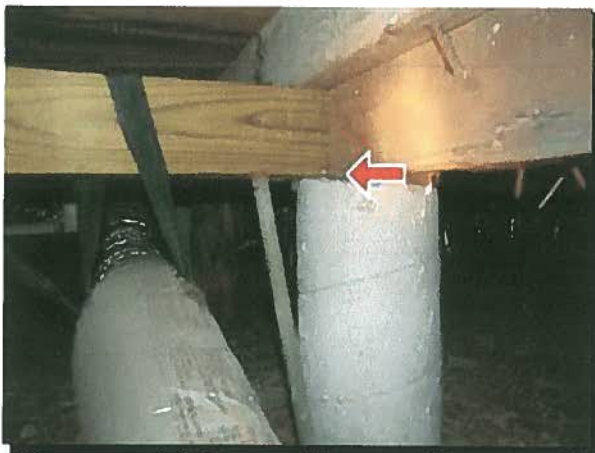
A. Picture 8

☒ Beams are not bearing fully on pilings in at least 8 areas.

☒ Old, original pilings (wood) should be removed, replaced.

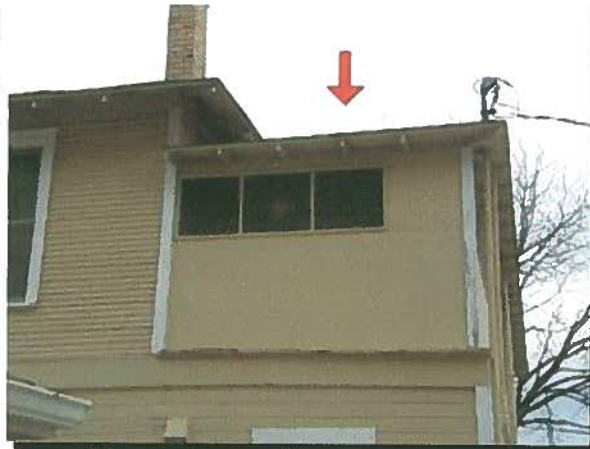
☒ The flat roof (Less than 3/12 slope) at the rear of home, covered porch has improper style roof covering (three-tab shingles). It should have either selvage, roll roofing, rubber membrane or an approved covering for a flat roof. The roof has evidence that it has been leaking (water damage and stains on ceilings).

C. Picture 2 Improper covering for low slope.

It is recommended that the roof from the main house be extended outward over the patio area to provide a continual drain slope towards the exterior of the structure. This will entail re-constructing the outer walls of the enclosure to conform with standard requirements for load bearing perimeter walls.

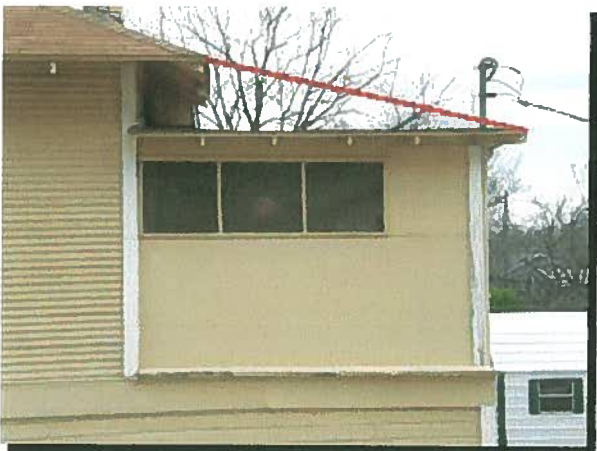
C. Picture 3 Recommend construction of properly sloped roof over covered patio.

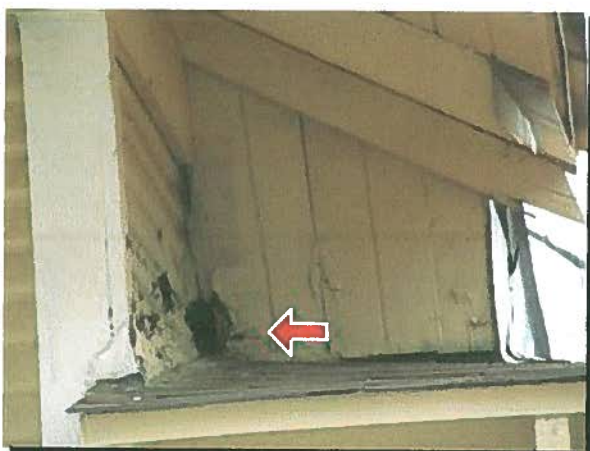
The existing roof is improperly flashed against the wall, under the eaves of the main house.

C. Picture 4 Wood rot under the eaves where lower roof covering is flashed into wall.

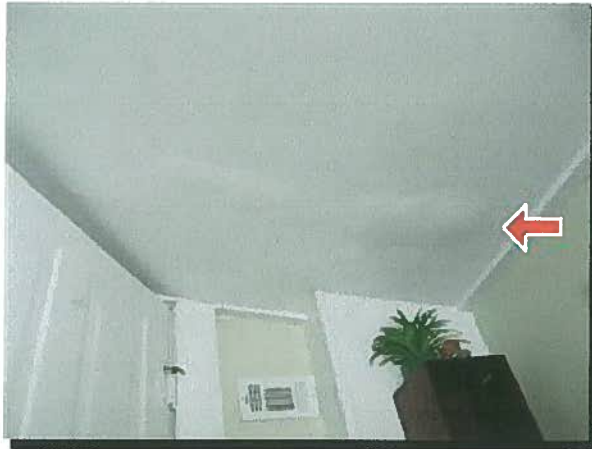
C. Picture 5 Evidence of leaks from flat roof, improper flashing.

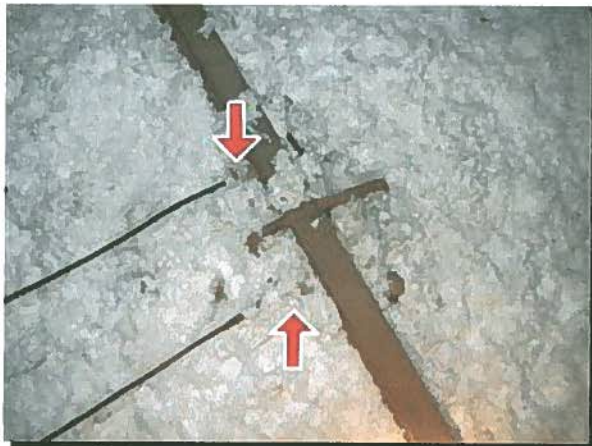
☒ Electric splices are not properly clamped or secured in junction boxes in various locations in the attic. There is knob and tube wiring present in the attic that has been spliced into. There are several areas that are safety/fire hazards and should be repaired and/or upgraded to current NEC (National Electric Code) standards. No additional insulation should be installed until branch circuitry in the attic is brought up to code.

D. Picture 3 Uninsulated cables through ceiling joists.

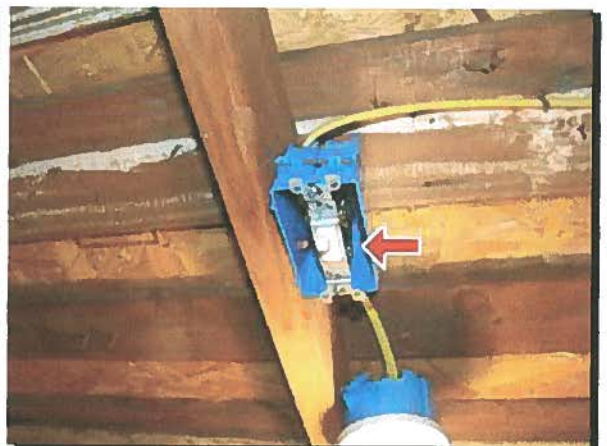
D. Picture 4 Prevent all access to live components.

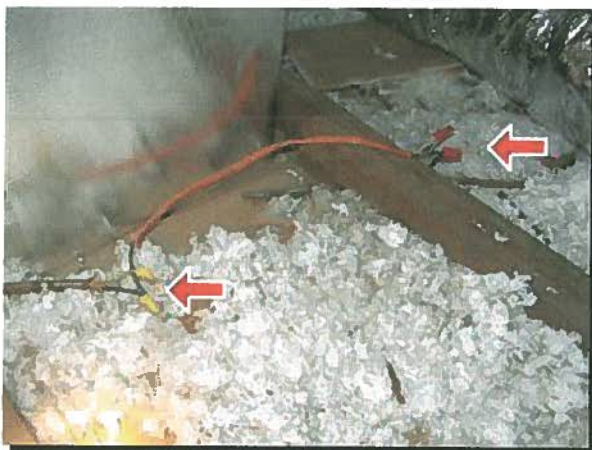
D. Picture 5 Improper connections made up in attic.

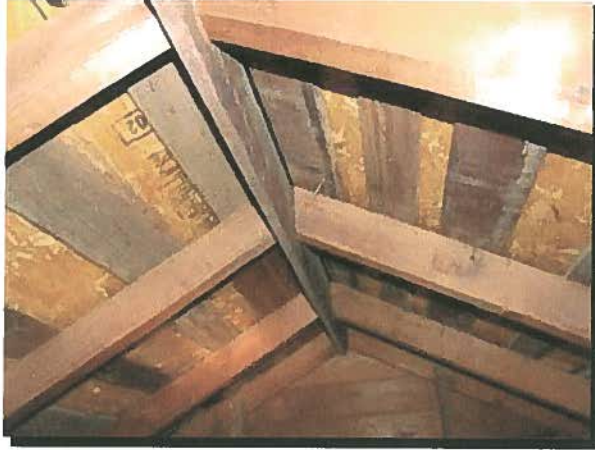
D. Picture 6

☒ The 1x6 inch ridge board should probably have been upgraded to a 2x6 at the last roof sheathing installment. A reduction of rafter span is a typical upgrade to structures of this era when additional load is placed upon it (plywood sheathing). The dead load weight rating of this structure is unknown, and an

evaluation by a structural engineer/specialist is recommended. Addition of purlins to reduce span of rafters is likely to be recommended.

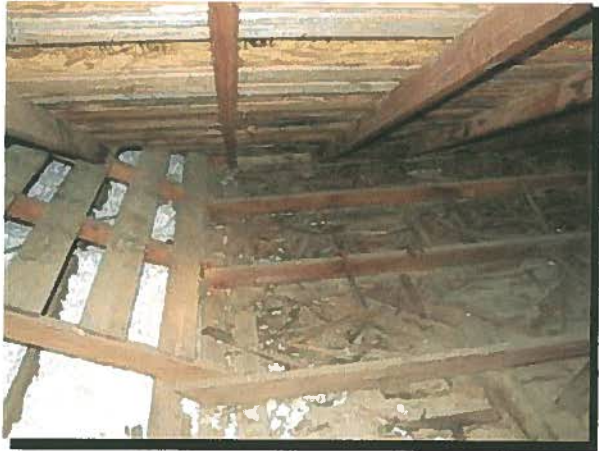
D. Picture 10

There is water damage to the front wall of the attic. No damp or dry in material present. Damp and dry in to be installed, extending under bottom of wall to exterior. Flashing will be needed at this abutment joint also.

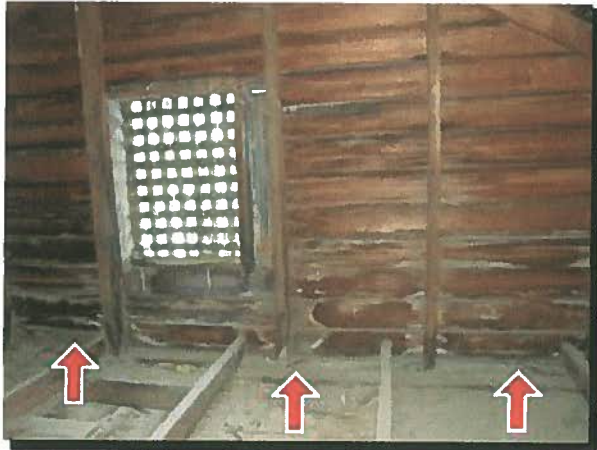
D. Picture 11 Run dry in to bottom, extending to exterior underneath wall.

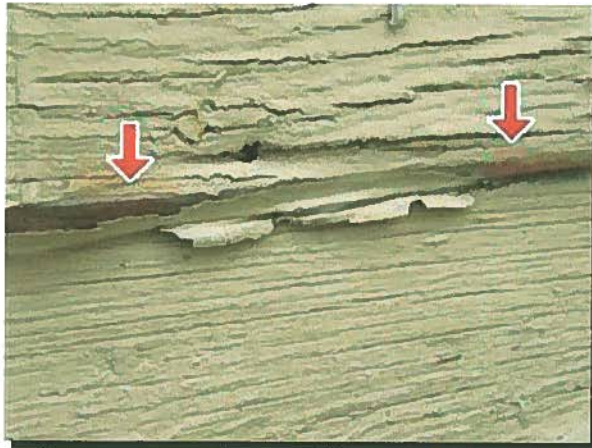
☒ An on site lead test showed presence of lead lead on wood siding. Lead is a known carcinogen that, when allowed to chip from siding and become ingested by children or pets, is a health hazard. Though most areas of house were painted over with non-lead based paint, the original lead paint is underneath. The deteriorating and chipped paint areas should be properly removed. Recommend contacting EPA registered contractor for maintenance advice, or for removal requirements if so desired.

E. Picture 1 Test solution turns pink to red upon presence of lead.

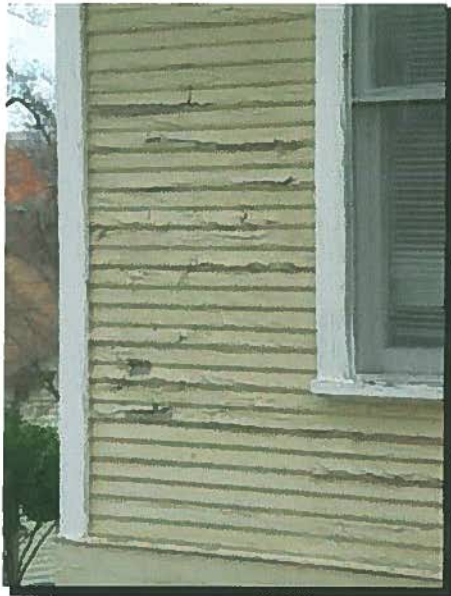
E. Picture 3 Pain to be removed.

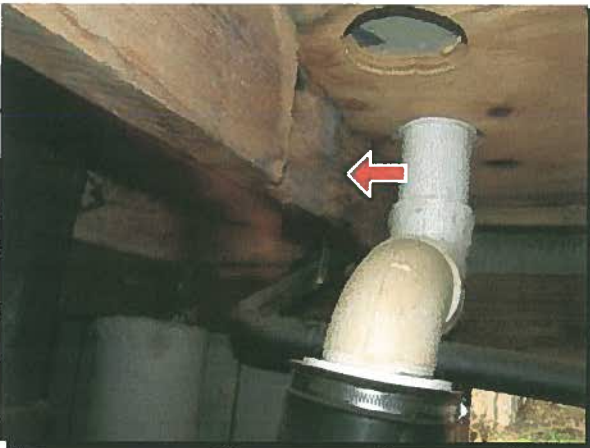
F. Picture 5 This one id not water damaged, but has been damaged from an attempt to modify, probably to accommodate the previous drain.
